Enhanced Preliminary Assessment Report:

Portland Army Housing Units
Portland, Connecticut

October 1989

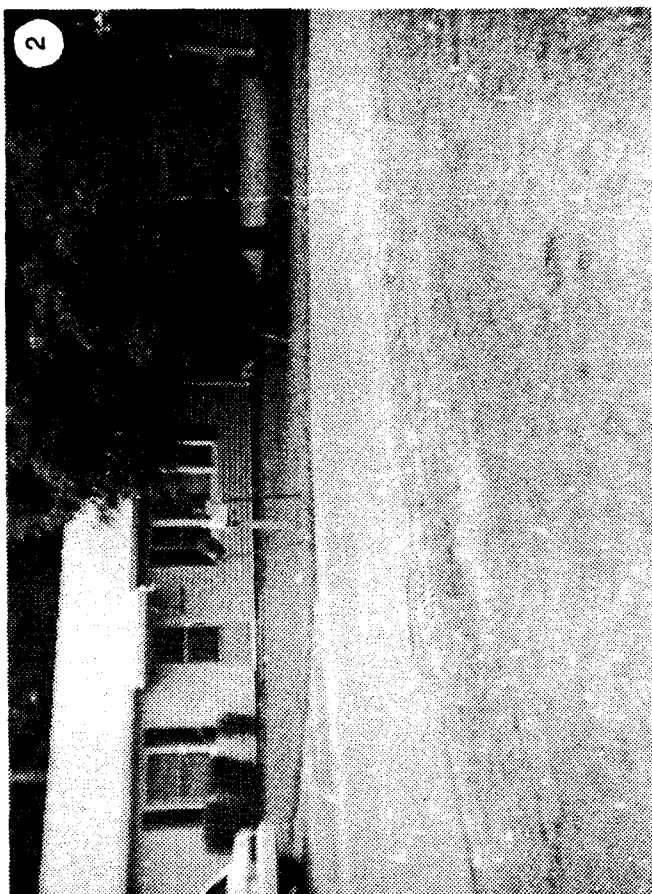
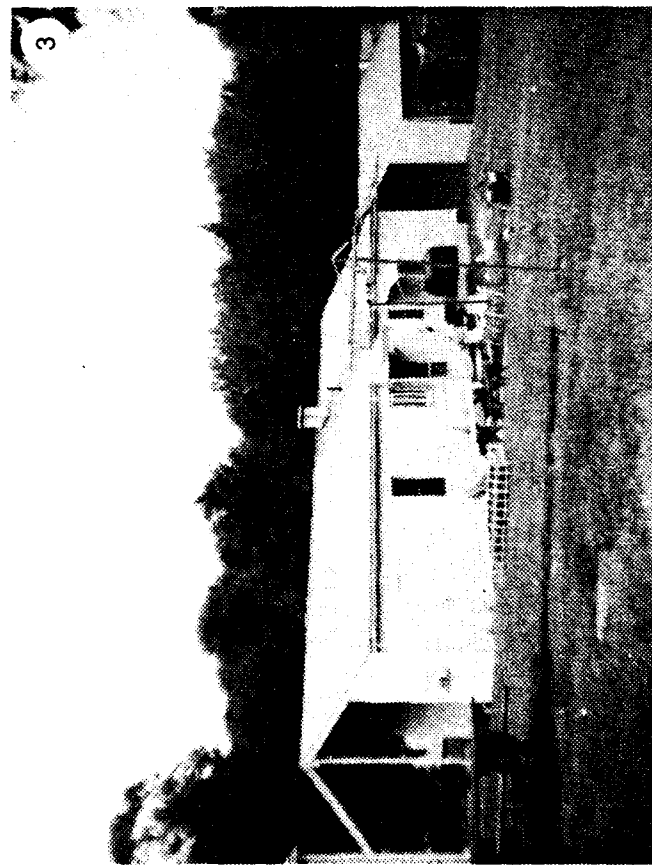
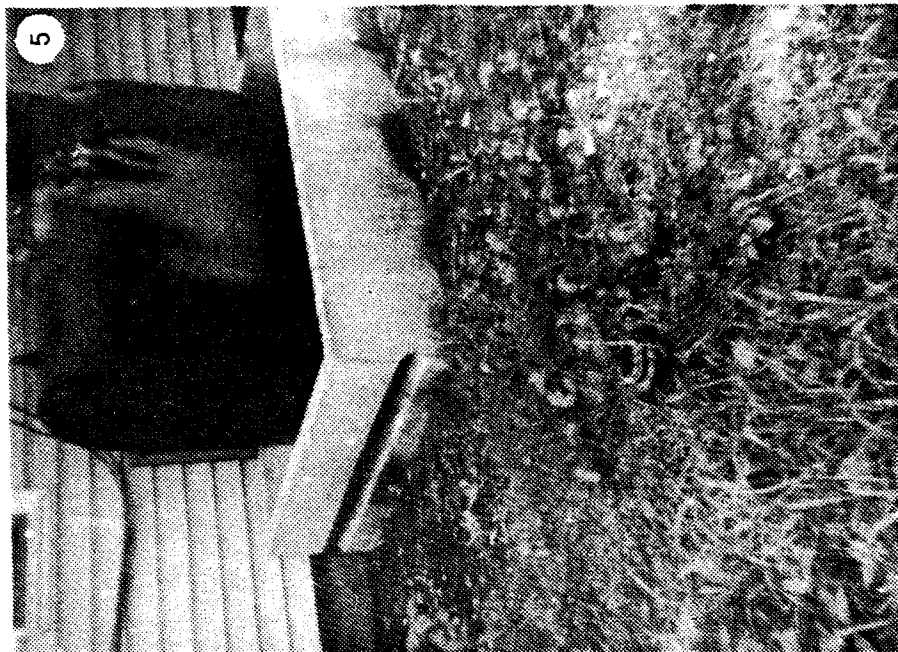
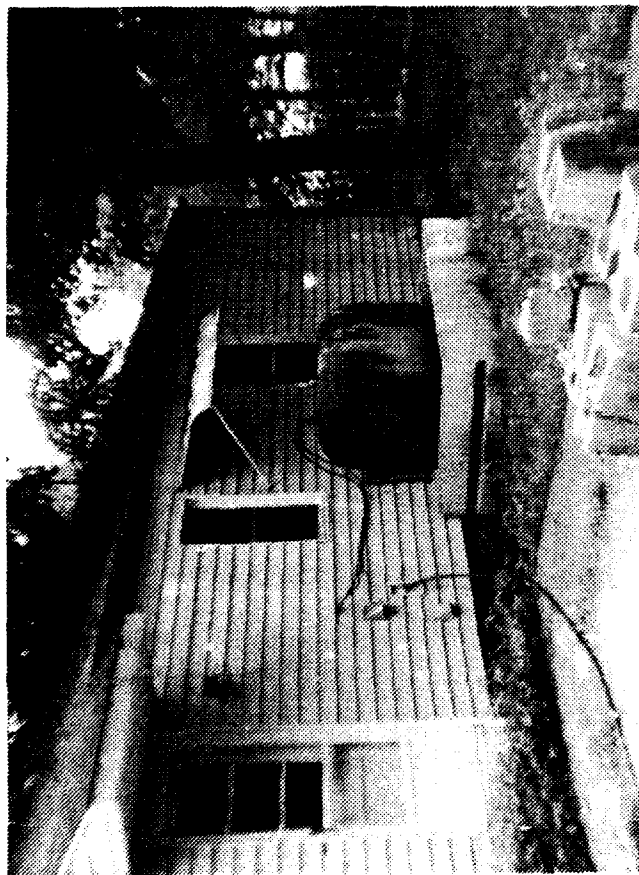
IDENTIFICATIONS OF PHOTOGRAPHS

1. The road leading to the housing area at the site entrance.
2. Front view of a Capehart housing unit. In the foreground, on the street, is a grated lid of the storm sewer system.
3. Rear view of a Capehart housing unit; attached carport at left.
4. Above-ground fuel-oil storage tank, concrete containment box, and overhead canopy to protect the tank, at the rear of a housing unit.
5. A close-up view of the above-ground fuel-oil storage tank and the concrete containment box; in lower center of view is the sealed-off inlet pipe to an underground fuel-oil storage tank; at this housing area, the original underground tanks are no longer in use but remain buried in place.
6. Lids of a septic tank; at this site, sanitary sewage service is provided by means of a septic tank system and individual leaching fields; sewage backup problems occurred at some units in the past.
